March 1976

NATIONAL AEROSPACE LABORATORY NLR

NLR TR 76035 U

SCANNING ELECTRON MICROSCOPY OF FRACTURE SURFACES OF CARBON COMPOSITE MATERIALS

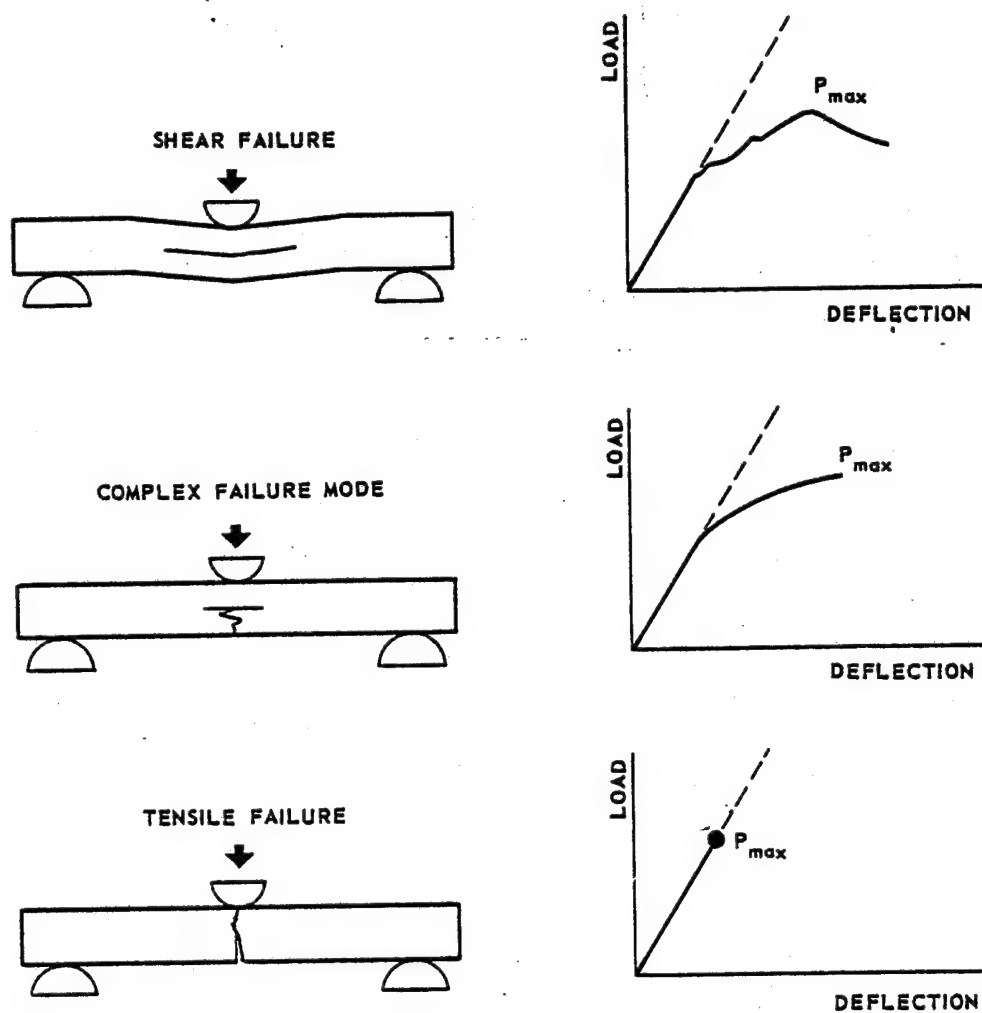
The ILSS and flexural strength were investigated by a three point bend test of a short beam specimen. It was anticipated that the fracture process might be a combination of shear and flexural fracture. The load-displacement curves associated with the different fracture modes are shown in figure 11.

Figure 11 Types of failure in short-beam shear specimens of u.d. composite material
